Manhole Inspection Summary

Manhole # S370__038MH

Inspection ☐ Is Incomplete Rating: **3) Fair**

Insp Date: **1/22/08 2:17 PM**

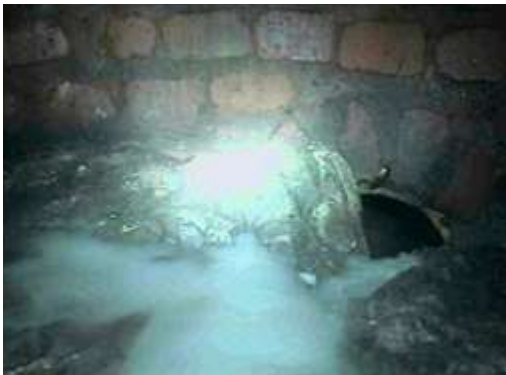
Defect 7

Condition: ☐ Sound ☐ Cracked ☐ Root Intrusion ☒ **Deteriorated** ☐ Leaks ☒ **Debris**

channel and bench debris, Bench and Channel Deterioration

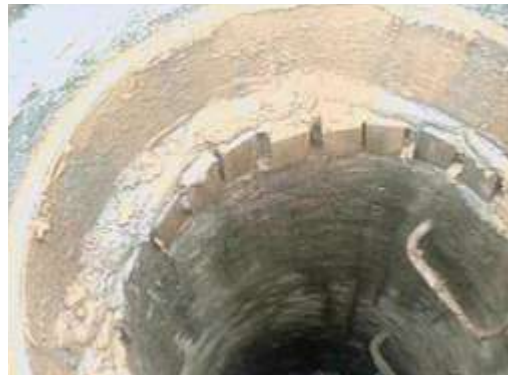
Defect 2

Frame Offset: **2** (in.) Condition: ☒ Sound ☐ Cracked ☐ Leaks

Condition: ☐ Sound ☐ Cracked ☐ Root Intrusion ☒ **Loose Brick** ☒ **Deteriorated**

Frame offset, Loose Bricks in Chimney, Chimney Infiltration

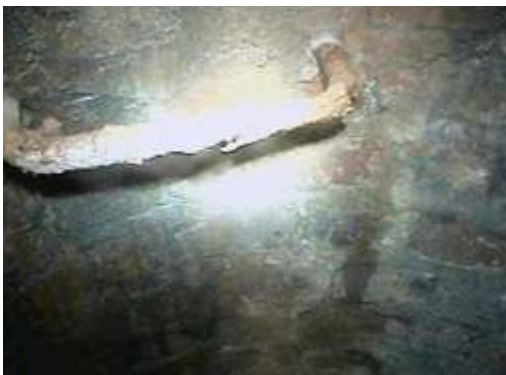
Defect 1

Steps Count: **6** Missing: **0** ☒ **Corroded**

Corroded Steps and Corbel Infiltration

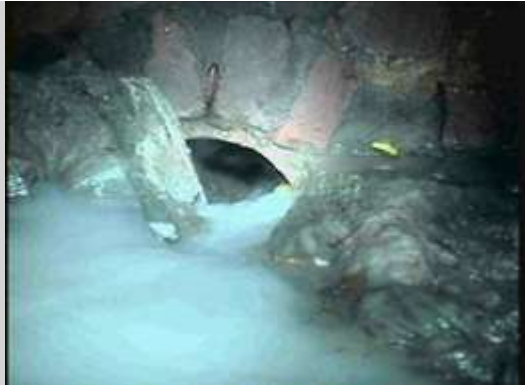
12 O'Clock Outflow

8 in. Circular Gravity Sewer
Pipe Out @ 12 O'Clock

Deposits: ☐ None ☐ Mud ☐ Sludge ☒ **Debris** ☐ Grease

Silt Depth: 6 (in.) Deposits Extent: **Heavy**

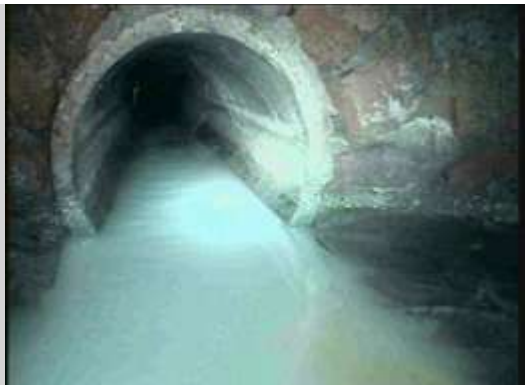
5 O'Clock Inflow

8 in. Circular Gravity Sewer
Pipe In @ 5 O'Clock
